Technical Memorandum

To: George Booth and Shayan Rehman, Sacramento County - Department of Water Resources
From: Graham Bradner and Jeff Twitchell, GEI Consultants, Inc.
Date: October 2018
Re: Existing Geotechnical Data Technical Memorandum
SCFRR - Community of Locke in Sacramento County

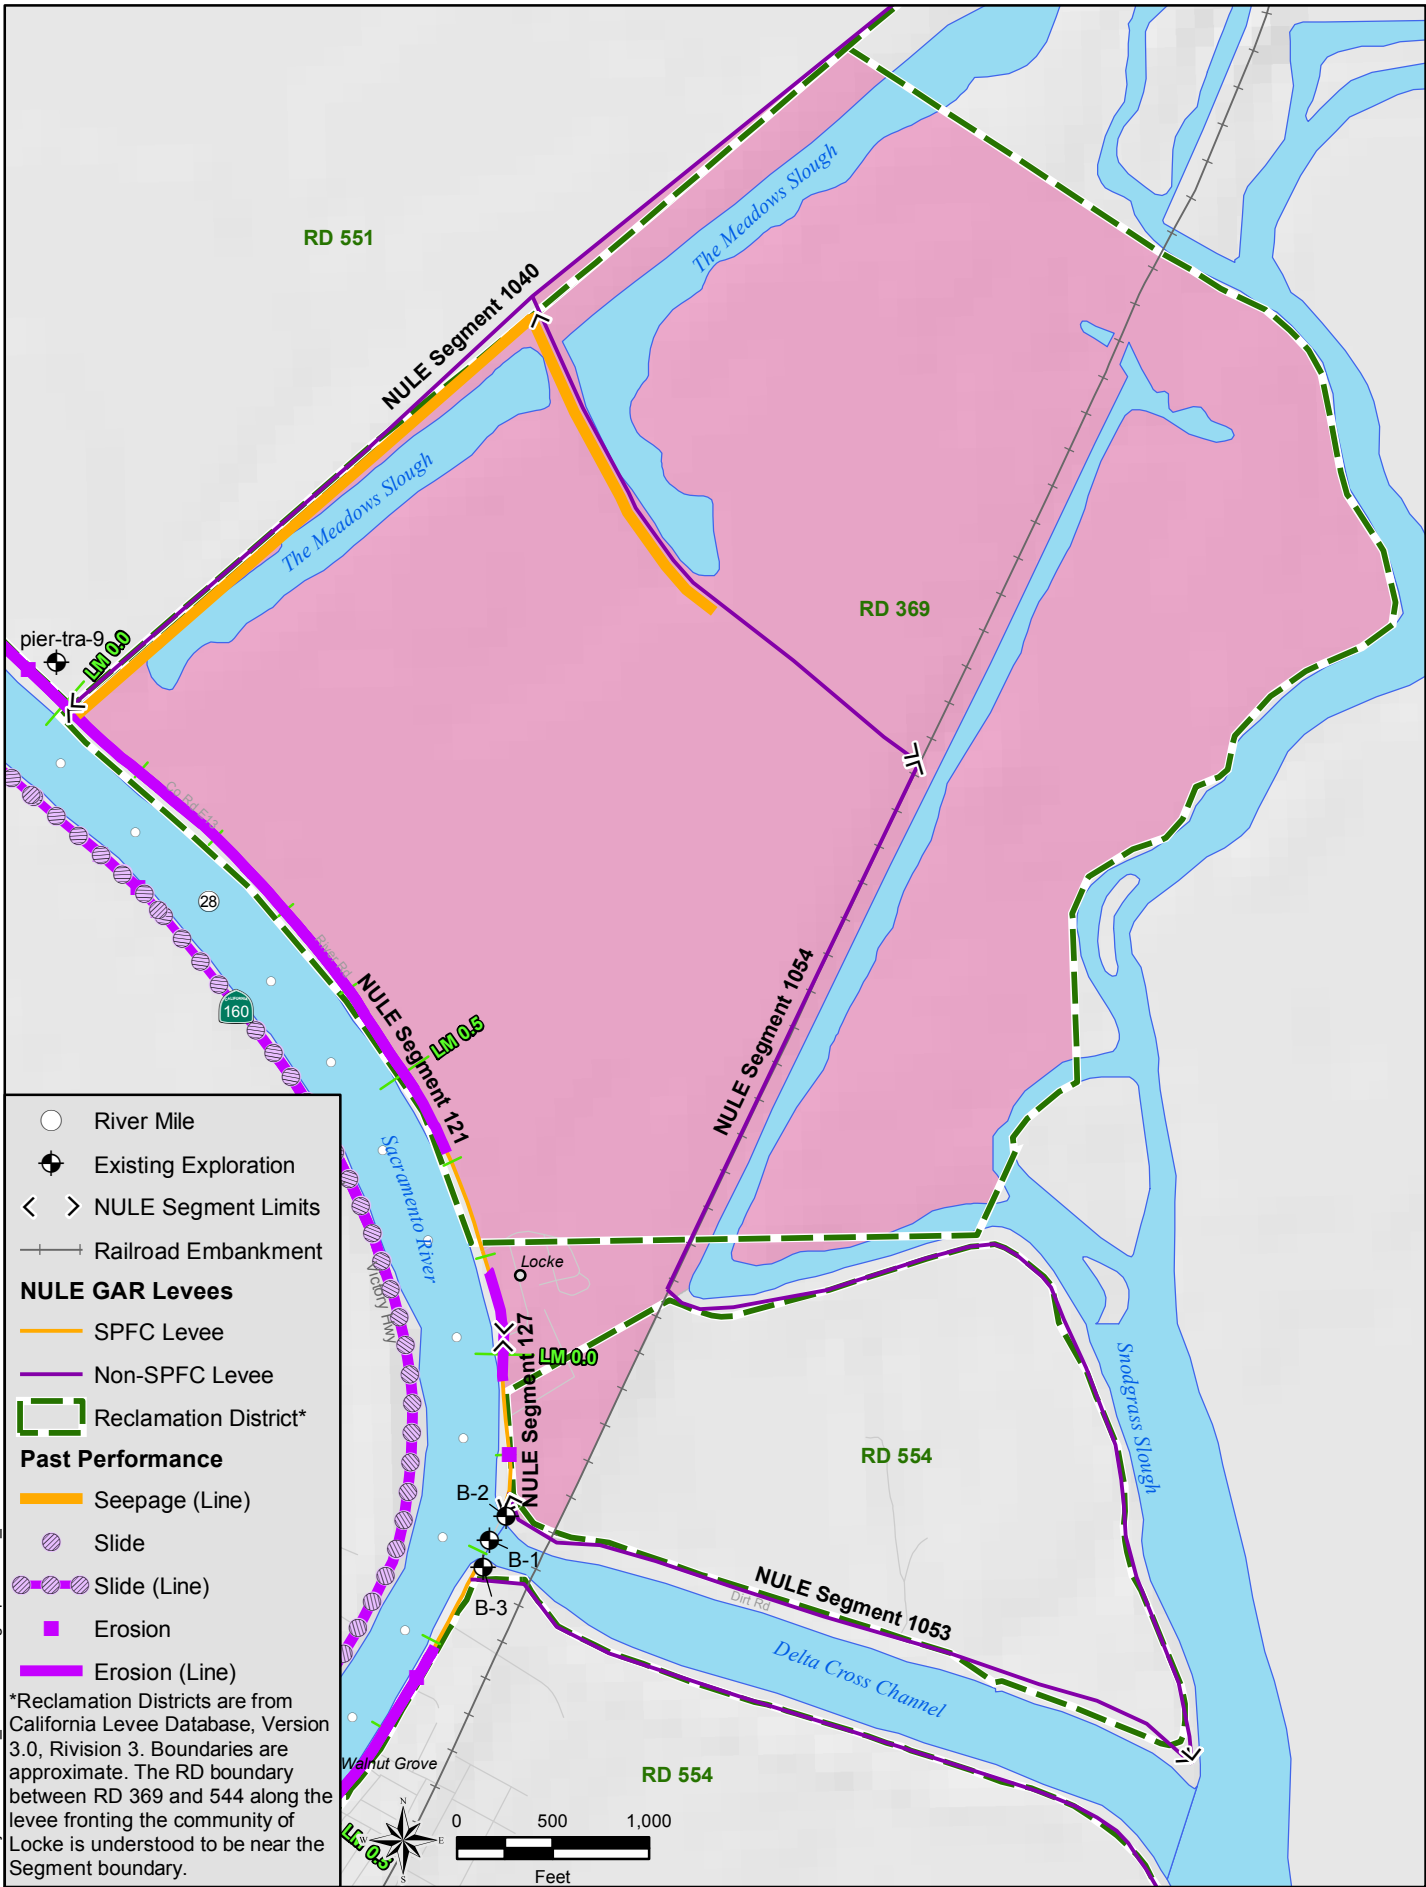
The report of seepage observed by landowners between 1949-1953 along the Meadows Slough levee (NULE Segment 1040, levee common with RD 551) was for seepage mapped on the Locke side of the levee, no other information is available. There were no identified records of past performance for the portion of the Snodgrass Slough levee protecting the community of Locke. Past performance is summarized in Table 1 and shown on Figure 2.

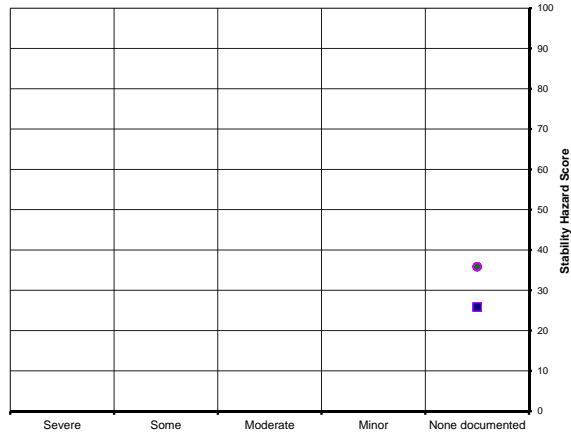
Stability Hazard Matrix, NULE Phase 1 Geotechnical Assessment

WHIS			Performance Summary			Categorization
Best Estimate	Minimum Credible	Maximum Credible	Best Estimate	Minimum Credible	Maximum Credible	
36	26	36	None documented	None documented	None documented	Hazard Level A

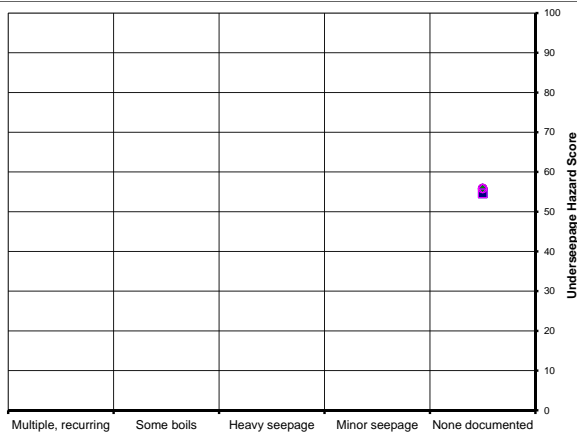
Underseepage Hazard Matrix, NULE Phase 1 Geotechnical Assessment

WHIS			Performance Summary			Categorization
Best Estimate	Minimum Credible	Maximum Credible	Best Estimate	Minimum Credible	Maximum Credible	
56	55	56	None documented	None documented	None documented	Hazard Level A
