Delta Annex Chapter 12 Reclamation District 2111

12.1 Introduction

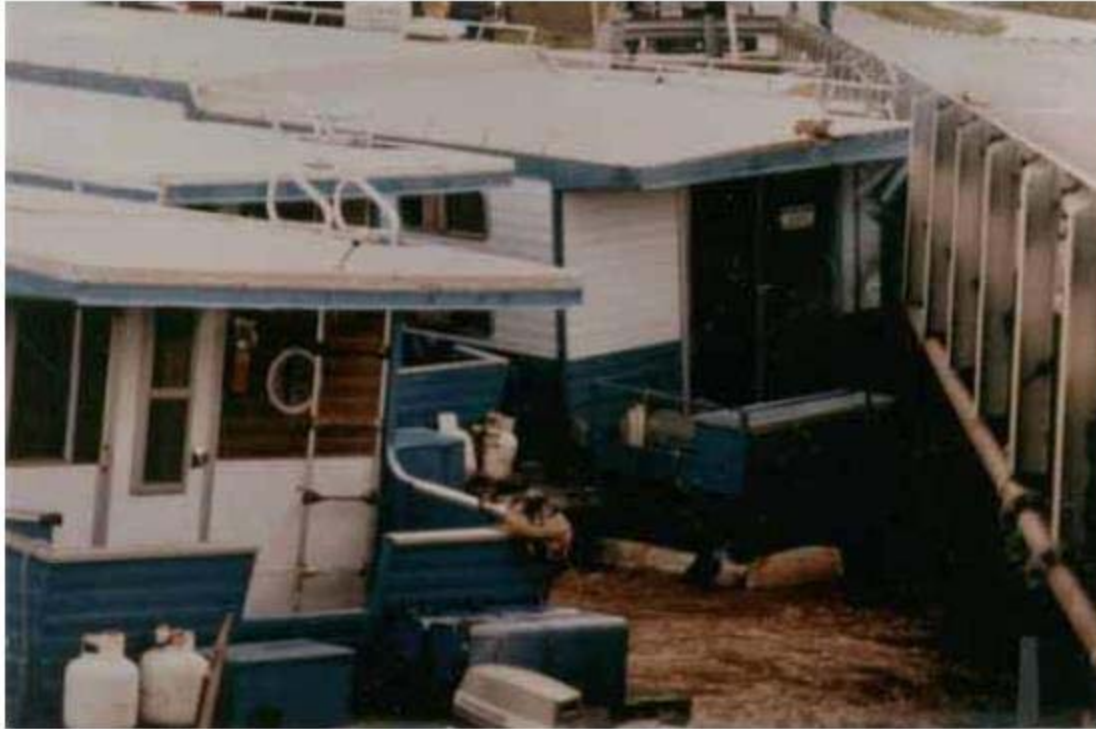
Source: 2015 Five-Year Plan for RD 2111

- February 1986 – The east end of the Island was overtopped. In the words of one of the District trustees, this flood event caused overtopping simultaneously “all over” the District. The location of the District at the confluence of the of the Mokelumne and Cosumnes Rivers caused a huge volume of water to overwhelm the District in a very short time, and the elevation of the levee was insufficient to protect the District against this rapid floodwater rise. The levee prism also failed as a result in the rapid pressure increase from the high water. In addition to the increased flow throughout the Delta, floodwaters around the District rose even further due to an unexpected flow restriction in the North Fork of the Mokelumne River at the New Hope Bridge, where several house boats had broken loose of their moorings and lodged against the bridge (see photo). The house boats had been docked at the New Hope Marina, located upstream of the split between the North Fork and South Fork of the Mokelumne River, near the western portion of the District levee. Note the marina blocking water that caused the RD 2111 levees to fail.

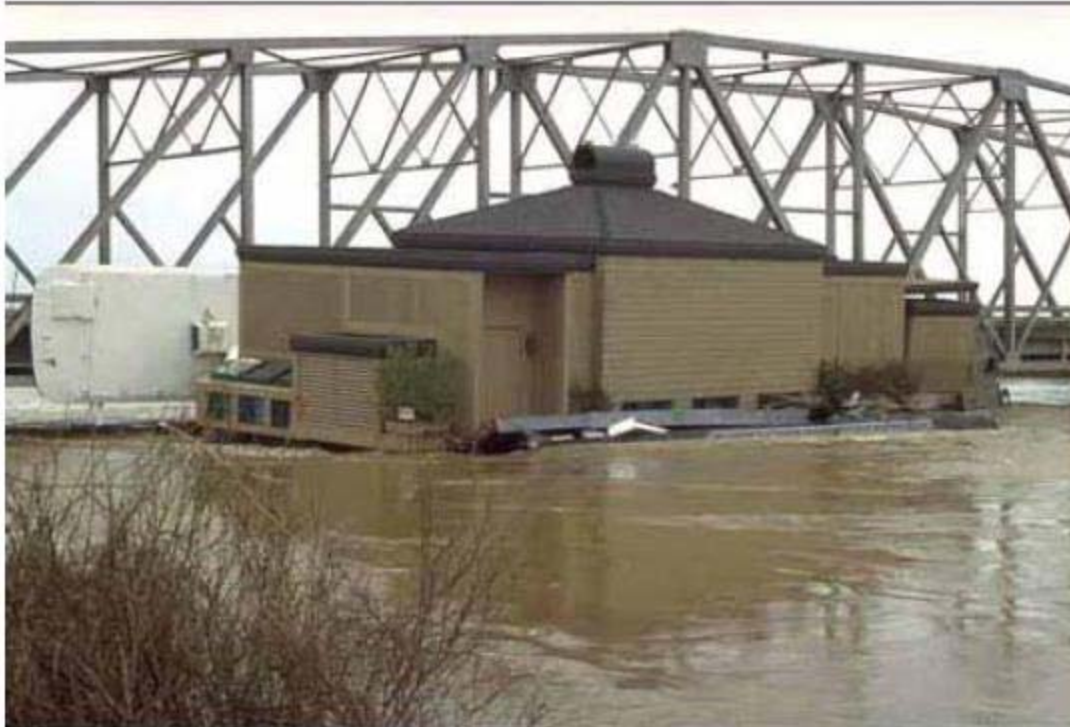
Source: 2015 Five-Year Plan for RD 2111

- January 1997 – The District levee failed at approximately Station 107+00 to 110+00 just as the levee was about to be overtopped. Consequences: A levee break occurred opposite the Walnut Grove Marina during a flood event. The District was fully inundated. Several boats and sections of the dock from the Walnut Grove Marina were pulled through the levee breach into the interior of the island. Other recreational boats, house boats, and sections of dock were also pulled into the Millers Ferry Bridge, including a two story floating home which particularly threatened to reduce flows down the North Fork of the Mokelumne River, increase the flood threat to adjacent islands, and possibly destroy the bridge, cutting off one of the few available emergency evacuation routes (see photo). The large house boat was eventually destroyed and the debris was sucked under the bridge.
