# Appendix 1

## REPETITIVE LOSS AREA 1 DRY CREEK

**Department of Water Resources  
Repetitive Loss Area Analysis**

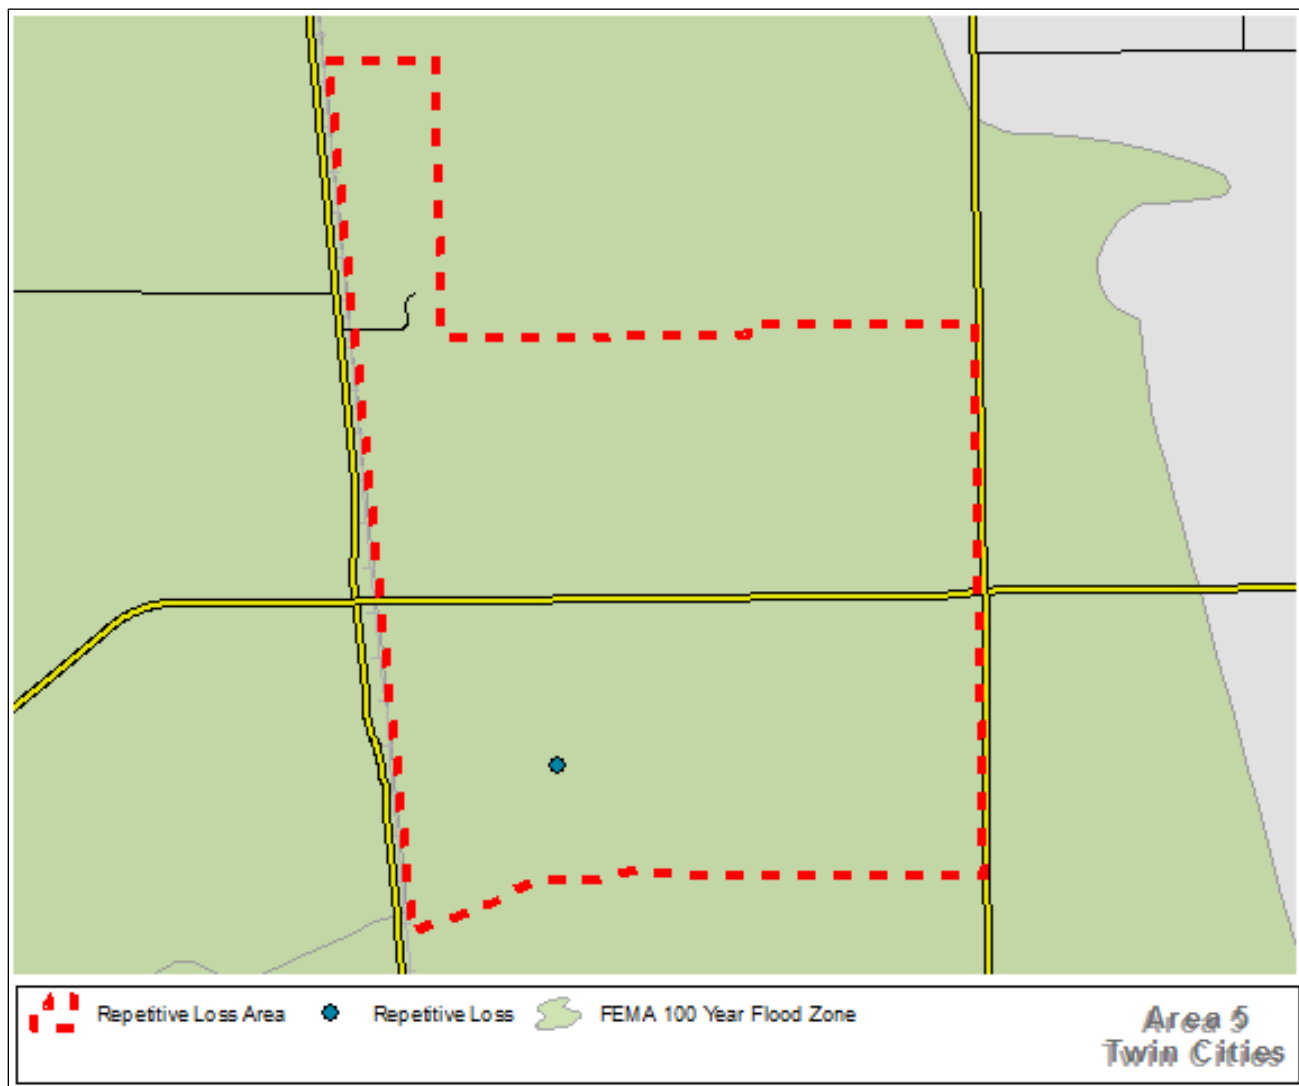
**FIGURE A5**  
**Repetitive Loss Area #5**

Based on the FIRM (August 2012) the repetitive loss area properties are affected by the 100-year FEMA floodplain. The flooding occurs when the Cosumnes River breaches its uncertified rural levee system combined with Beach-Stone Lake floodwater and contributions from the Morrison Creek watershed.
