Delta Flood Emergency Safety Plan
 Sacramento County, California

ESTIMATED FLOOD DEPTHS FOR A HYPOTHETICAL
 LEVEE FAILURE LOCATED AT SACRAMENTO RIVER

Figure D1A

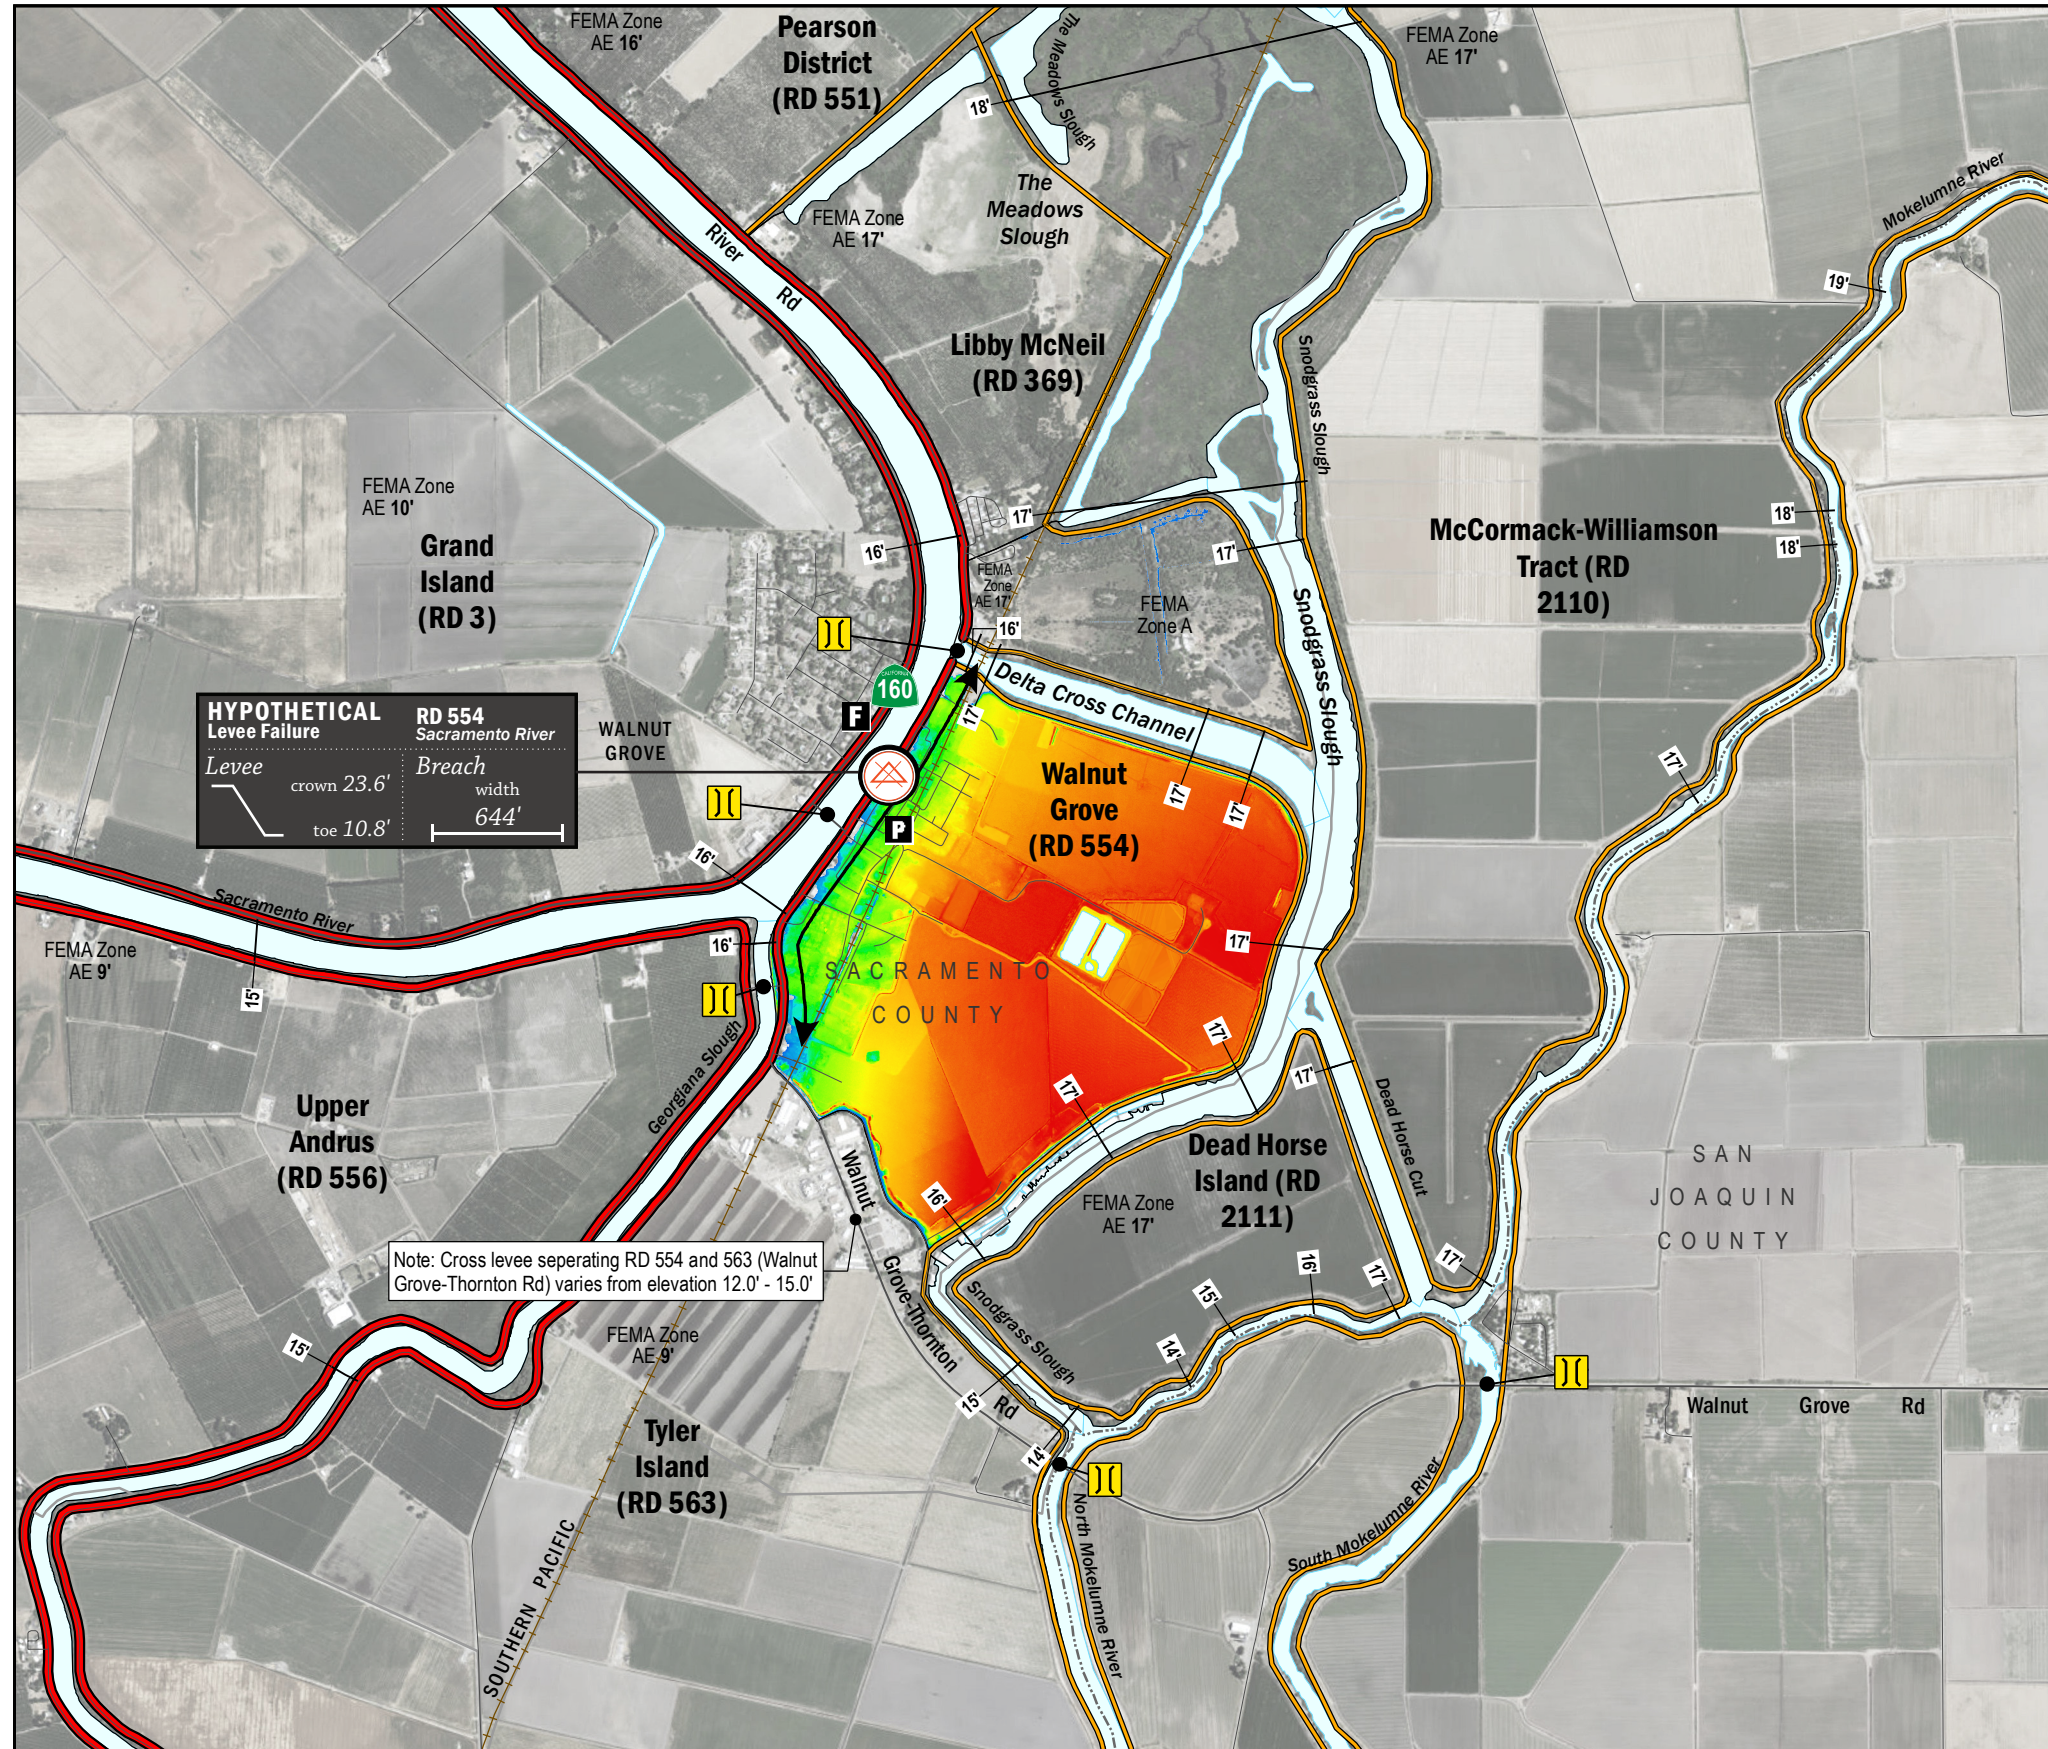
ESTIMATED FLOOD DEPTHS

HYPOTHETICAL Levee Failure
 Levee crown 23.6'
 toe 10.8'
 Breach width 644'

Note: Cross levee separating RD 554 and 563 (Walnut Grove-Thornton Rd) varies from elevation 12.0' - 15.0'

Hypothetical Levee Failure Location
 Arrows Indicate Breach Extents

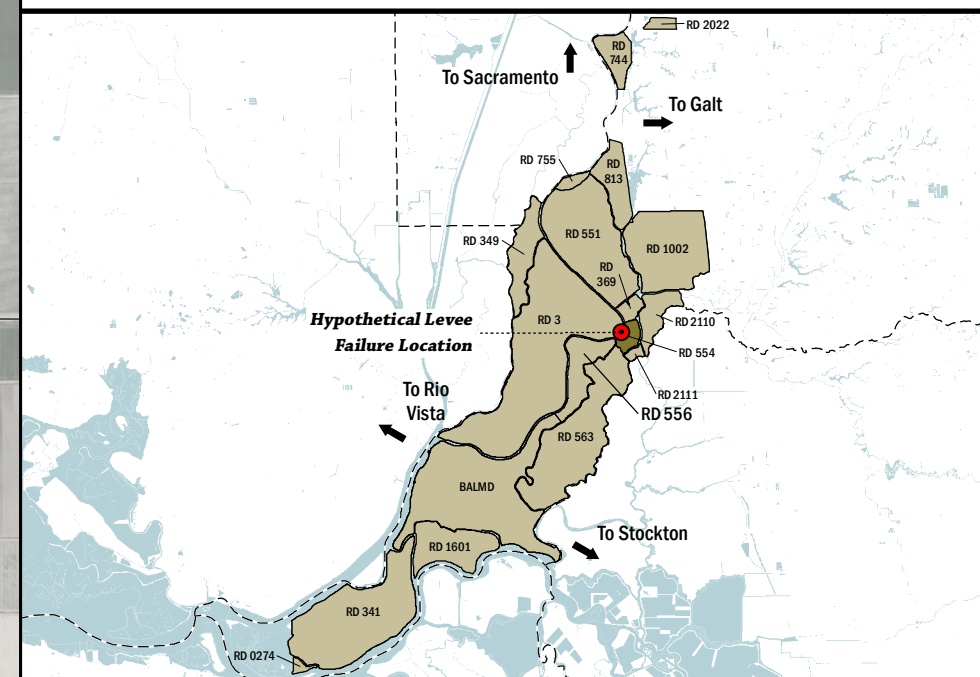
- NOTES**
1. The hypothetical levee failure location is arbitrary. Similar results would occur from a Sacramento River levee failure within the limits shown on the map. The depth of flooding after failure will vary based on operations (flow and volume) from the Sacramento River.
 2. Maximum water surface elevation will vary between elevation 12.0'-14.0' (NAVD88)
 3. The time to maximum depth after levee failure is approximately 1 day.
 4. Elevations are provided in NAVD88 datum.
 5. FEMA Zone AE Elevation 9.0' (NAVD88) is the 1% annual chance base flood designation for RD 554 due to non-accredited levees.
 6. The levee failure opening width was an approximation based on the difference between the maximum water surface elevation and the landside toe times 50.
